# VISUAL CONDITION ASSESSMENT REPORT

Newton Public Library  
Newton, KS

**Gossen Livingston Architecture**  
420 S. Emporia  
Wichita, KS 67202

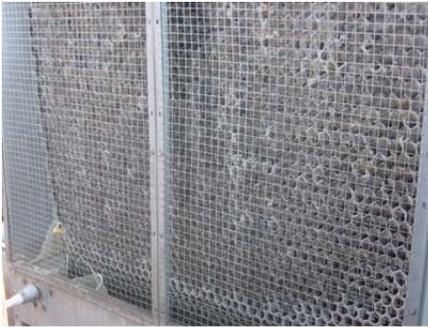
**Cooling Tower:** The roof-mounted cooling tower is a Marley Aquatower, and is approximately 12-15 years old. Although efforts have been made to maintain the cooling tower, it is showing signs of deterioration and is near the end of its useful life. The associated piping and pumps show significant signs of rust. Given the condition of the tower, it is obvious that water treatment has been a problem in the past even though it has improved in the recent years.

Photo 1: Scaling on back of cooling tower.

As mentioned and shown above, the cooling tower, along with some of the piping and accessories, should be replaced in the very near future. Developing an extensive water treatment plan would also be a vital component to ensuring efficient operation and extending the life of the new equipment. It would reduce maintenance if we could replace the cooling tower with a piece of air-cooled equipment, but that option is not seen as feasible since the chiller in the mechanical room was replaced with a water cooled unit a relatively short time ago. The water cooled chiller appears to be operating well and the users reported no problems associated with it.

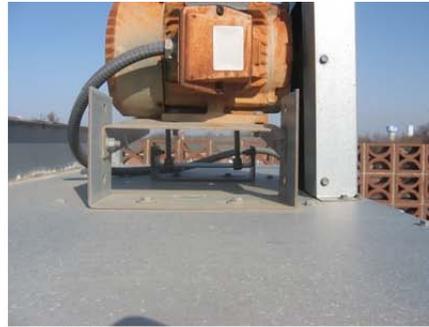
Photo 2: Rust on pump and piping on cooling tower.

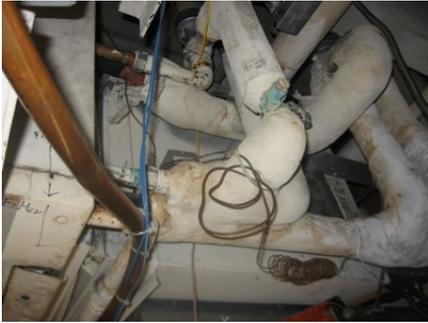
Photo 3: Fan coil unit piping above ceiling. Access to the unit is poor due to the pipe routing. Insulation and piping is in poor condition.

The larger air handlers appear to be functioning well at this time. However, the outside air intakes to them are not ideal. Dirt, leaves, and other debris have an easy path to the outside air stream through the grates mounted at grade level. It is recommended that the outside air ducts be re-routed to new roof hoods or to wall mounted louvers in the exterior wall (above grade). Chases would have to be added to make this a possibility, but the indoor air quality would be improved and maintenance requirements would be significantly reduced. The fan coil units throughout the building are at the end of their useful life. They all have maintenance access problems due to either their location or the piping blocking the access panels. At a minimum, the piping runouts to the units should be replaced as it and the insulation is in very poor condition.

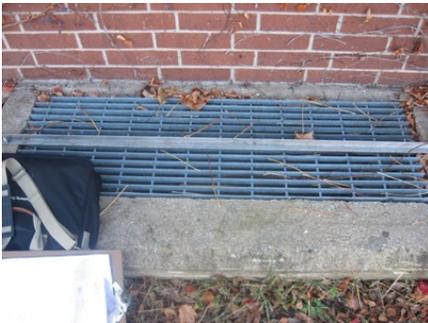
**Air Handlers:** The larger air handlers throughout the building have been well maintained and appear to be functioning well. The users reported small problems with them, but nothing more than usual maintenance items such as replacing belts. The smaller fan coil units are hard to access and are at the end of their useful life. Insulation on the piping near these units is in bad condition and is routed in such a way that it makes accessing the units very difficult. Outside air is delivered to all of the air handlers through grates at grade level near the building as shown in the photos below. This makes keeping leaves and debris out of the outdoor air stream an impossible task.

Photo 4: Outdoor air must travel through grates to get down to the wall louvers below.

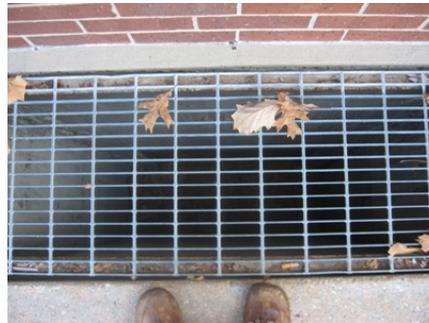
Photo 5: Leaves and other debris fall down through the grates and get into the outdoor air stream.

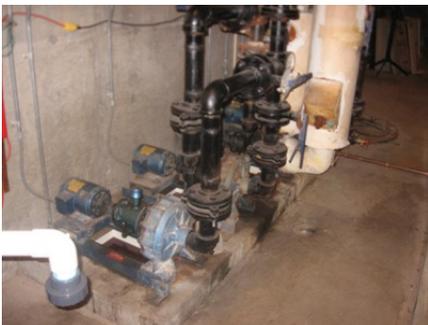
**Pumps:** The hot and chilled water pumps are close coupled end suction pumps and appear to be the original pumps. They have been well-maintained and are still in operation, but are showing signs of deterioration. Users reported substantial maintenance requirements associated with the pumps.

Photo 6: Existing pumps.

The hydronic pumps are the original pumps. As stated above, they have been well maintained, but should be replaced in the very near future as they are at the end of their useful life.
